## **Percolation Tank cum Check Dam constructed at ridge portion has produced good results at valley portion**

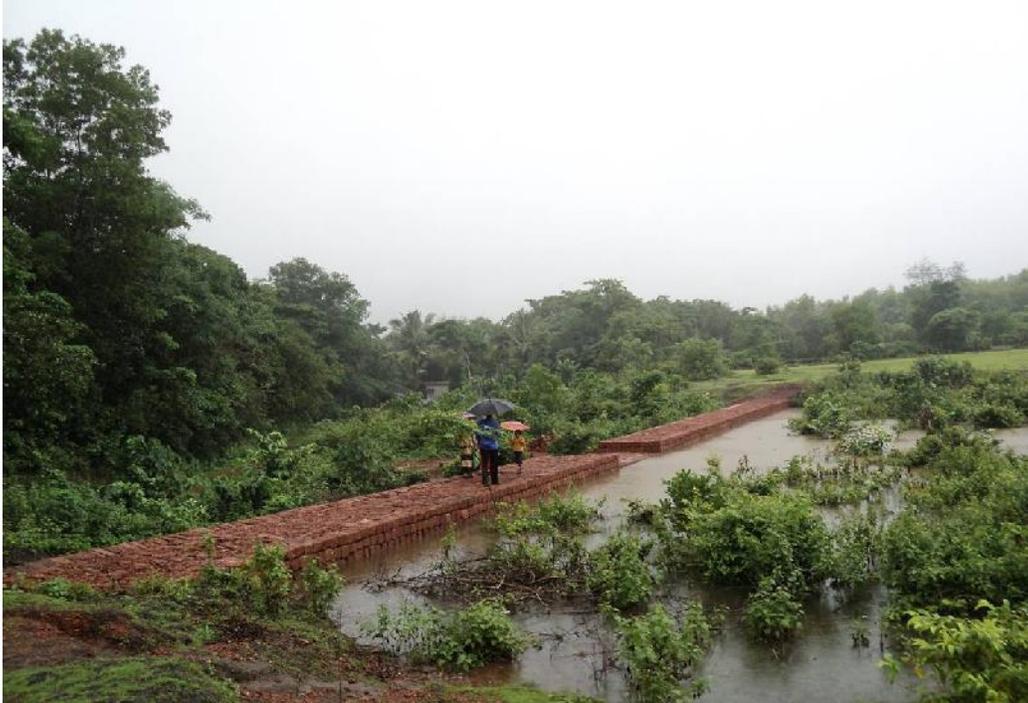
### **The Structure constructed**

In the rainy season of 2011, the structure regulated the speed of runoff water and the problem of flooding was resolved for the first time. In that rainy season, the farmers could retain their cattle assets at their original sites and no colour change (contamination) of well water was observed. Runoff water was first collected and stored in the tank and it slowly percolated. This has contributed to water table augmentation in valley portion. The water table in the open well of Mr. Balagopala was observed. On 31 March 2011, the

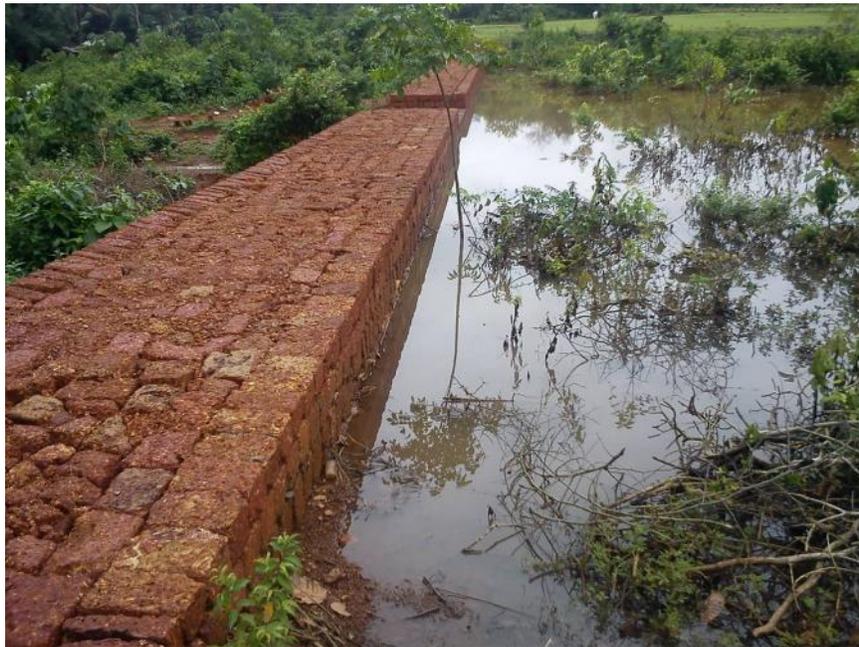
#### **A close view of the structure**
